# GULLY REMEDIATION

## Geoff and Maureen McCarthy

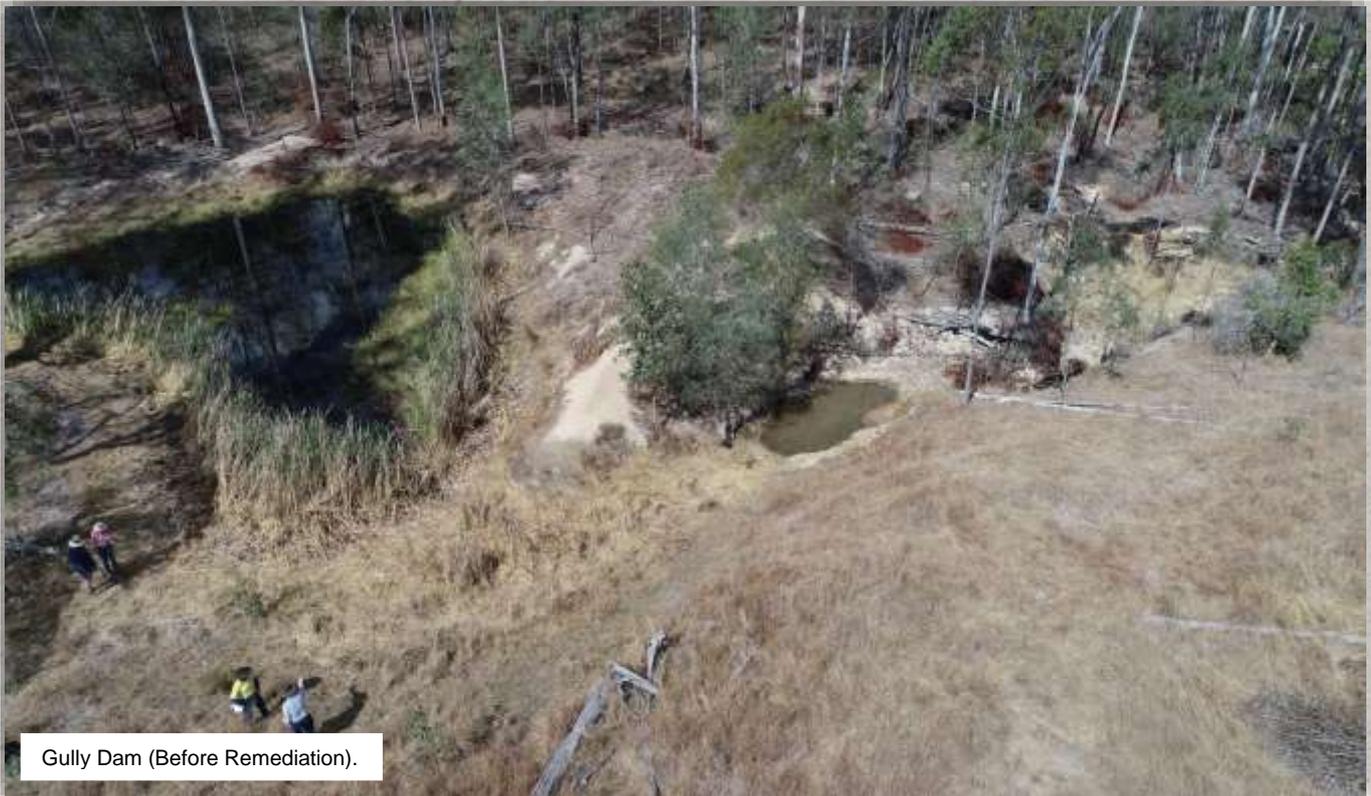
Gully Dam (Before Remediation).

The damage to the by-wash was due to its width being inadequate to accommodate expected flows. The water collected by the by-wash also returned to the stream too close to the back of the dam wall, creating a risk of 'gullying' into the dam.

Part of the by-wash was cut away by a 4.5m long gully which eroded the by-wash down to bedrock. The bedrock was scoured to a depth of 1.5m - 3.0m and full of holes and cracks. The eddying and turbulence effects created by these holes resulted in erosion of adjacent banks. The peak concentration of the water and the eddying effects became significant threat to the integrity of the dam wall.

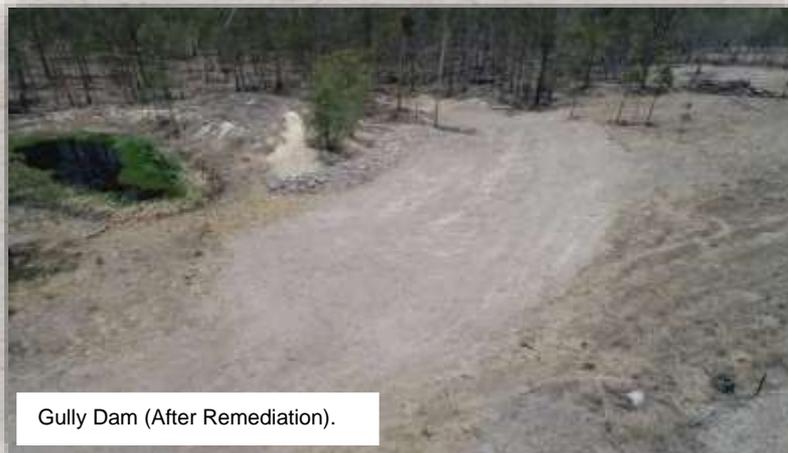
Gully Dam (After Remediation).

The existing lip of the by-wash was deliberately left intact to improve the structural integrity. Topsoil was removed to increase the width of the by-wash and spread back over the site to facilitate revegetation. Re-establishing ground cover is vital as above ground plant components help to slow water moving across the landscape. Below the surface, fibrous root systems help to hold the soil together, reducing erosion risk.

A rocky extrusion on the McCarthy's' property supplied rock for battering exposed and vulnerable sections of earthworks. Larger rocks were broken into smaller angular material, which packs together better for armouring. A gravel / rock mix of 100mm - 500mm diameter was used to counter an expected flow of 10m<sup>3</sup>/sec.

However, this width was impractical due to a hill that bordered the by-wash. To avoid the cost of additional, extensive earthworks, a 10m by-wash was constructed. This width is still wide enough to accommodate most expected flows.

The by-wash was constructed with a 200mm fall along its 10m width to take the fastest flow away from the wall. The by-wash was then levelled out after several metres to prevent undue channelling of water. To further protect the integrity of the dam wall, a diversion bank was built along the side of the wall out to where there was a more suitable return slope. The diversion bank was armoured with rock to prevent erosion and consequential threats to the wall's integrity.

The end of the dam wall was also armoured with rock and built up to 1m above the by-wash, allowing enough freeboard to prevent overtopping of the wall. Given that the dam wall end on the by-wash is most at risk, a log was embedded into the rock armouring to give further protection and channel water away from the wall.

A rock chute was also constructed to slow water returning from the by-wash to the stream.

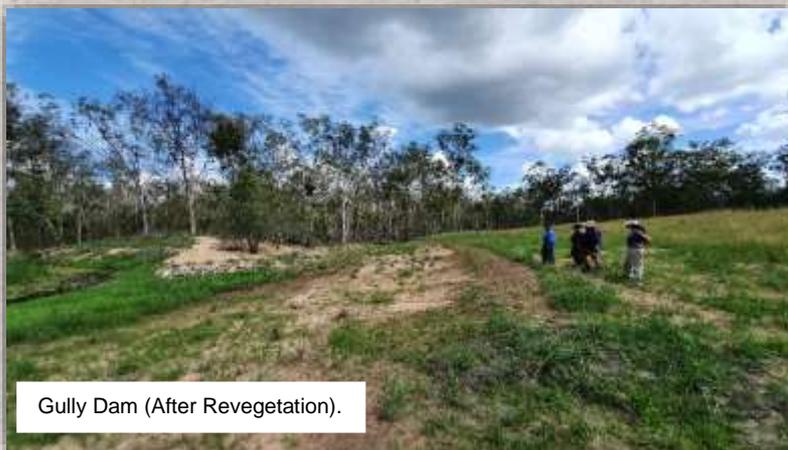
Gully Dam (After Revegetation).

After the earthworks were completed, Geoff and Maureen hand planted the site with Pangola grass (*Digitaria eriantha*). Pangola's ability to shoot out runners enables it to spread quickly and hold strongly to the soil. Unlike other 3P (productive, palatable and perennial) grasses, which mostly form tussocks, the runners grow roots at each node, making the plant well anchored with a large 'footprint' over the soil. In comparison tussock grasses can result in 'pedestalling', a type of erosion where water swirls around the tussock taking soil away from the base of the plant.
