# Flood Recovery Case Study Recovering Prime Agricultural Land

## Schmidt Property Branyan - Lower Burnett River

### The Project - Part 1: Gravel & Sediment Removal

## The Project - Part 2: Riparian Repair

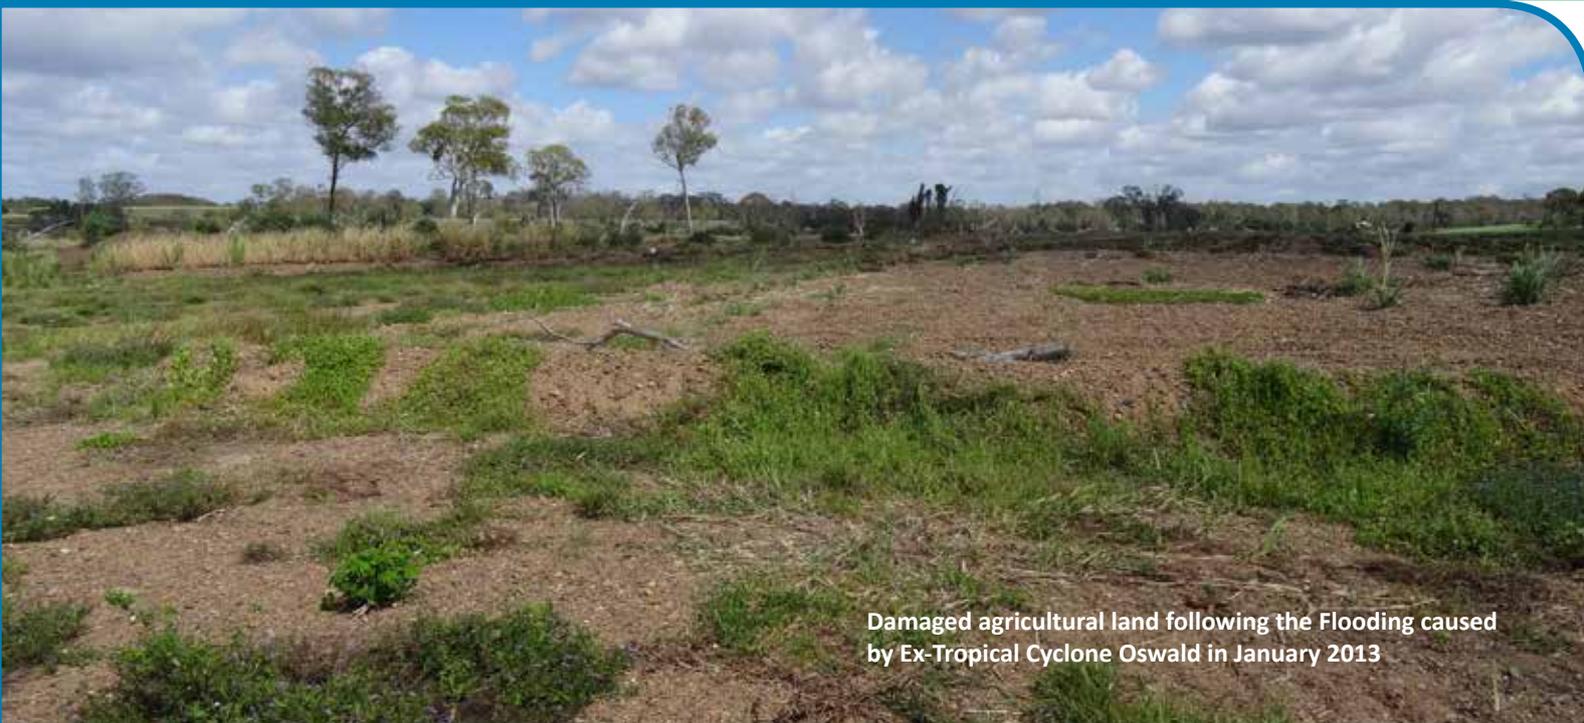
Damaged agricultural land following the Flooding caused by Ex-Tropical Cyclone Oswald in January 2013

John Schmidt's property at Branyan is located directly downstream from an abandoned sand and gravel quarry. The size and speed of the floodwater deposited a layer of up to one meter of sediment over the sugarcane crops from the unprotected quarry. Some of the cane was totally covered and in other areas only small green stems were left exposed. Twenty-three ha of sugarcane was effected seven ha described by John Schmidt as “unrecoverable”. It is estimated that this block could have been covered with up to 50 000 m<sup>3</sup> of gravel. To reinstate this block would have been a task outside the capability of the farm.

Once the sand and gravel was removed from the block and stockpiled, the final layer of gravel/soil mix was stripped and used to reclaim the headland that had been eroded away. Reinstating the headland allowed for maximum use of the original block for planting crops.

“Due to the mass of the gravel compacting the ground and the high levels of machine activity, the field required extensive ripping and ploughing to allow planting to occur” said John. He has taken this job upon himself and his first cover crop was planted in December 2014. Now that this land has been returned to production, it should generate \$20,000 in revenue for the farm and the land value is now restored after becoming rendered worthless while it was covered with gravel.

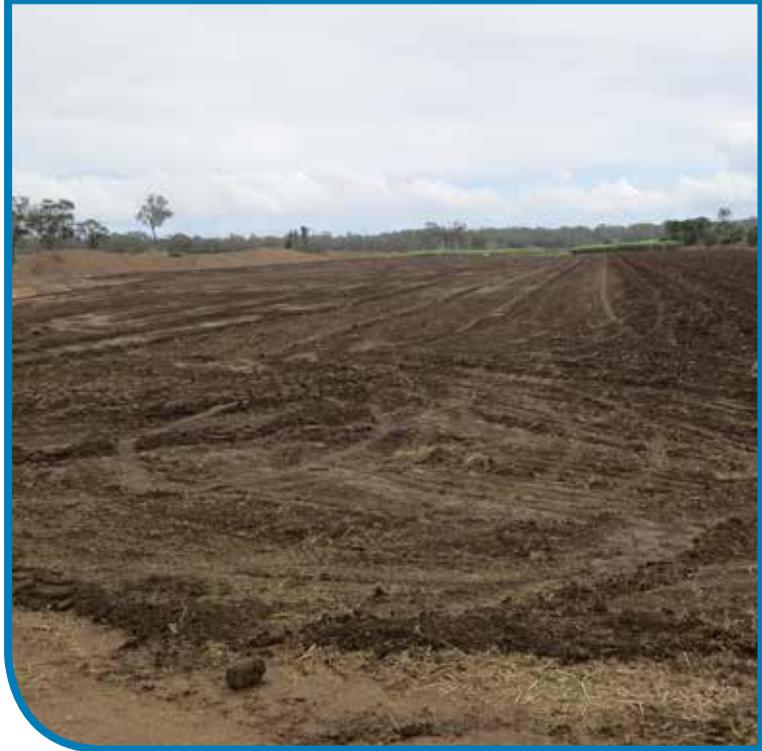
Top: Recovered land after restoration and ready for planting.  
Below: Installation of rock wall and revegetation to stabilise the bank
