# GULLY REMEDIATION

## Heather Fricke

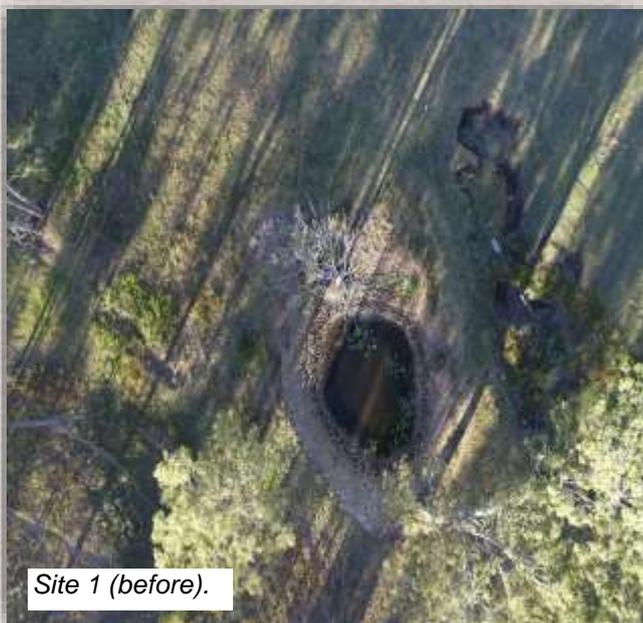
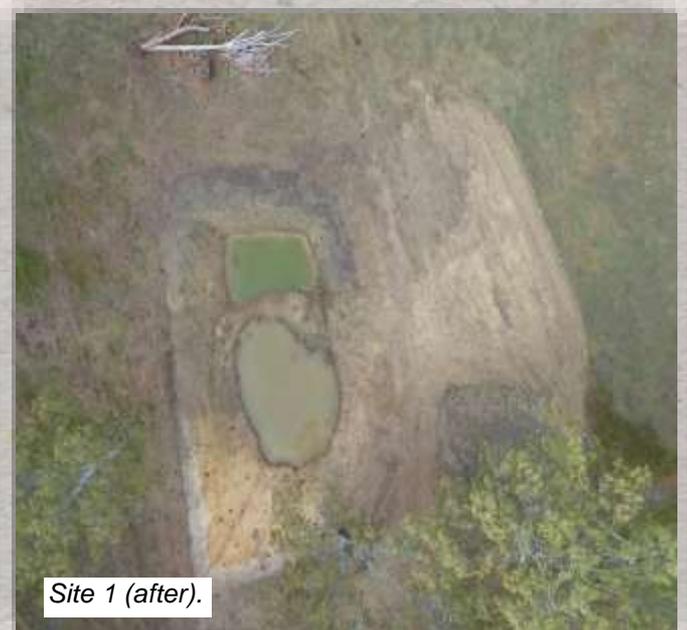
**Site 1** - The current dam's water holding capacity was insufficient throughout extended dry years. As part of the project, the earthmoving contractor was able to dig out the dam, which in this instance, provided suitable material to use in further remediation.

To repair the eroded by-wash, the gully head and walls were battered at a 3:1 ratio. The depression was then filled with spill from the dam and used to create a new by-wash.

The extension of the dam by-wash ensured water could spread over a wide, gentle slope. Due to the size of the catchment it was important to ensure the water could re-enter the drainage line in a slow and controlled manner to avoid further erosion downstream.

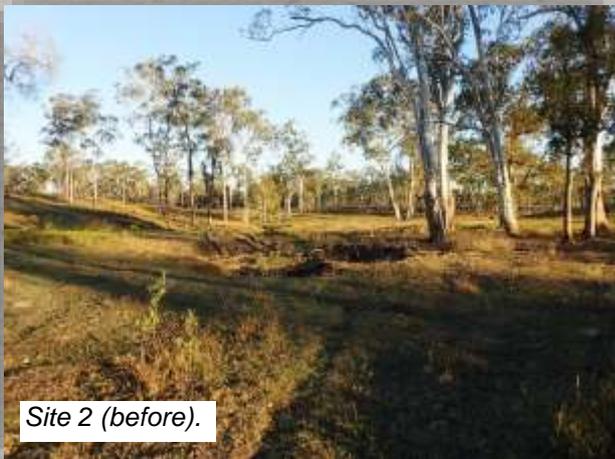
**Site 2** - To rehabilitate the gully at Site 2, the gully head and walls were battered back and then filled with the remaining spoil from the dam deepening.

Site 2 (before).

To protect the filled and compacted site, a short diversion bank was constructed to divert water onto a well-grassed, stable area.

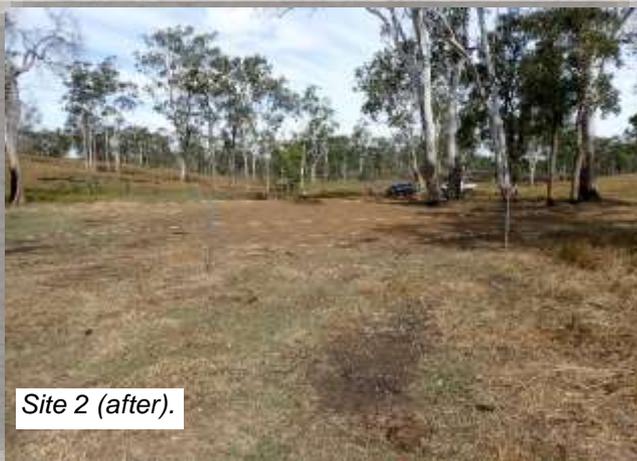
Site 2 (after).

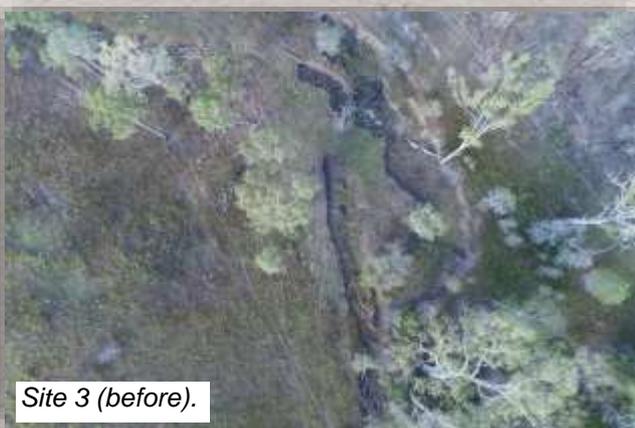
**Site 3** - The paddock containing this gully did not have a water source except the creek, so a dam was constructed to provide stock with water and flood the eroded area.

Site 3 (before).

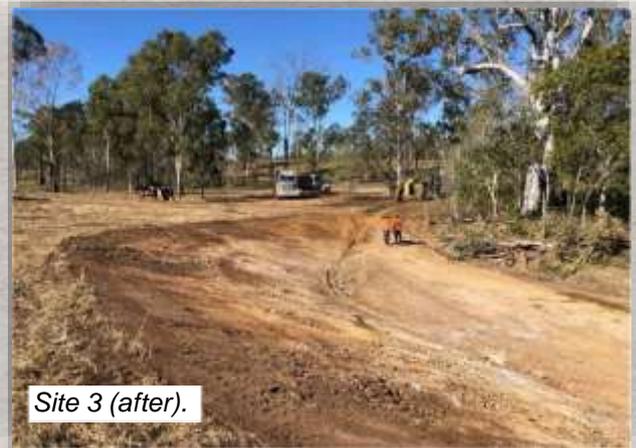
Similar to Site 2, the gully head and walls were battered, and the upper reaches of the gully were filled with spoil to level out the channel and spread the flow of water. In the lower section, a dam was built to flood other eroded sections of the gully. The new dam will also capture any soil which is lost from the other sites higher up in the catchment.

Site 3 (after).

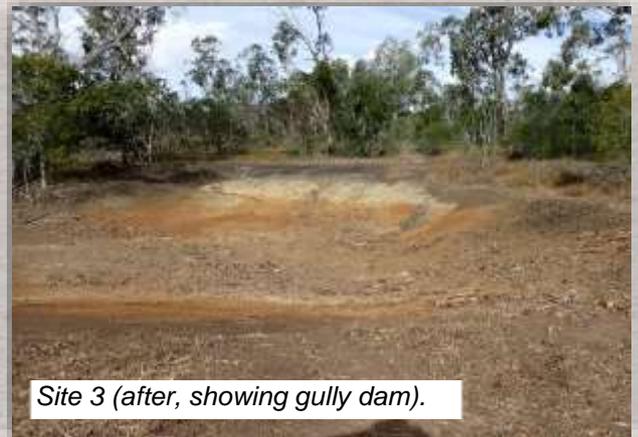
Site 3 (after, showing gully dam).
