### Dowling Property, Airport Drive MONTGOMERY Three Moon Creek

Earthworks were implemented to remove two point bars which caused Three Moon Creek to break its banks and severely impact adjacent production land during flooding caused by Ex Tropical Cyclone Oswald in January 2013

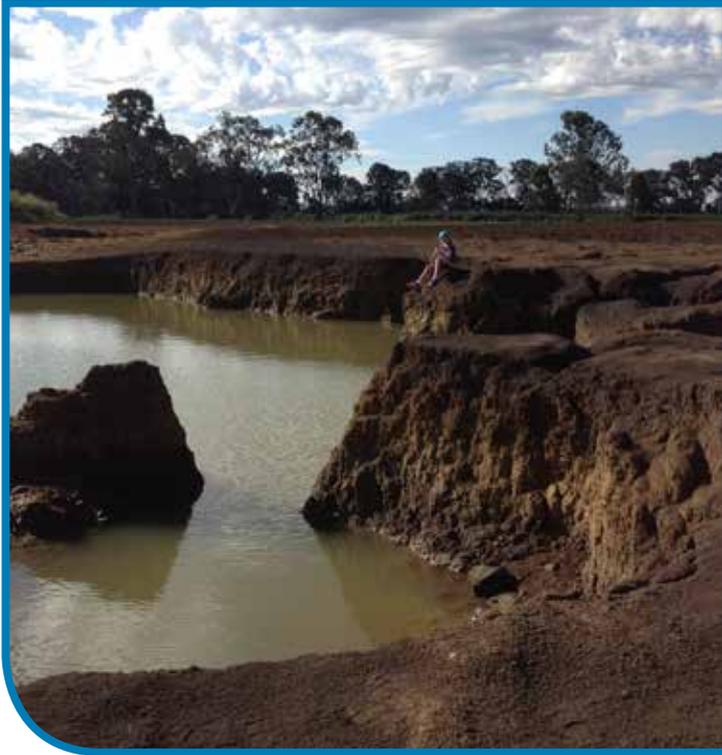
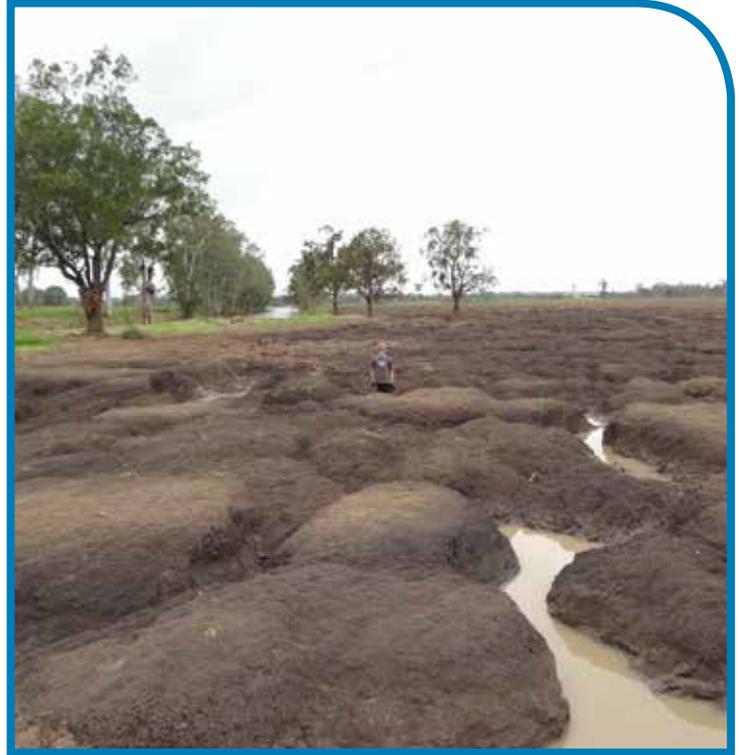
Severe scouring and loss of topsoil from production land adjacent to Three Moon Creek following the flooding caused by Ex-Tropical Cyclone Oswald in January 2013

An earthmoving contractor was employed to undertake the rehabilitation works. Sand deposits which make up the point bars was excavated out of the creek.

This removed material was used to raise the level of the crossing along with other nearby materials, where required. Raising the crossing by approximately 300mm will be required, while ensuring the existing crossings structure is still maintained.

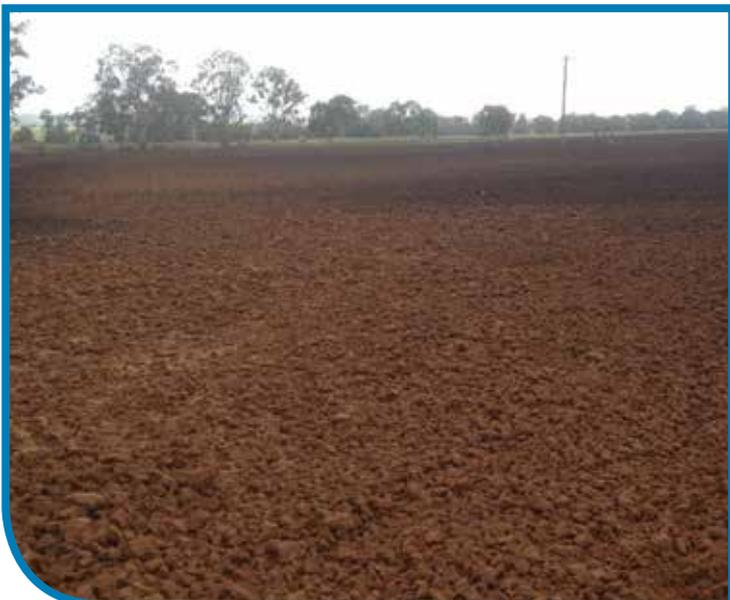
Same paddock one month following flooding caused by TC Marcia in 2015 - plowed and ready for planting. Removal of the two point bars reinstated the natural flow of Three Moon Creek

Following the 2015 TC Marcia flooding event, the landholder has advised that this project was particularly successful. Having the point bars removed avoided the two stream effect— where streams meet, with swirling causing considerable damage as occurred in 2013. The 2015 flooding caused by TC Marcia was as extensive as 2013, however, damage in this area on the property was significantly less—the Three Moon predominately followed its original flow path with limited flow into the area which caused the damage in 2013.
