### Radel Property - Staatz Road, Monto Three Moon Creek

#### Background

The 2013 flooding caused by Ex-Tropical Cyclone Oswald damaged the natural levee bank on the Radel property. Left unattended the break in this natural levee would leave the adjoining agricultural land on the flood plain exposed to scouring in future flood events.

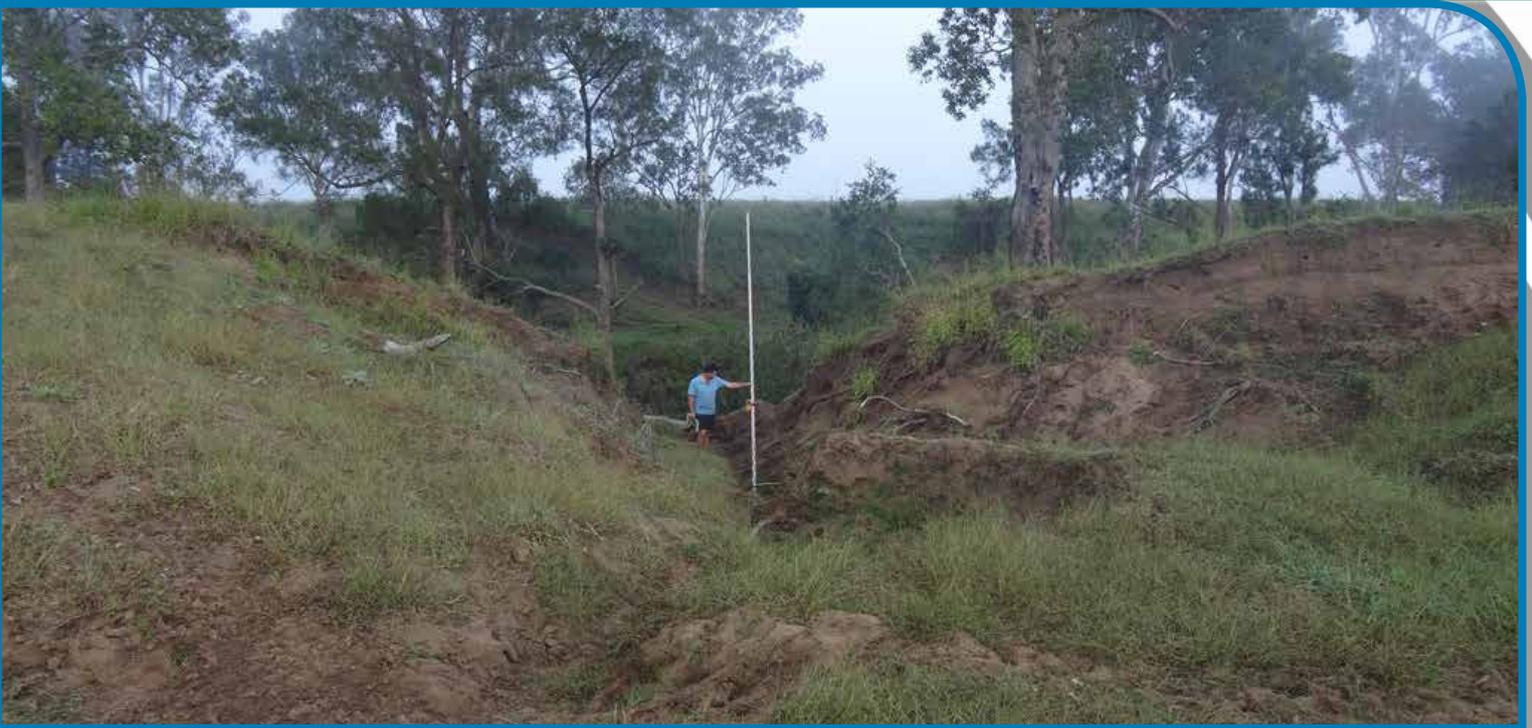
Break in the natural stream bank levee caused by flooding caused by Ex-Tropical Cyclone Oswald

The project aimed to restore the natural levee to pre 2013 dimensions and was recommended in the Three Moon and Monal Creeks Floodplain Management Plan Action Program 5 – *Stability of creek banks and natural levees where by it states that “Breaches in the natural levees of the Three Moon and Monal Creeks be restored and permanent vegetation established”.*

Suitable fill material (sandy silt to sandy clay) was sourced and placed in approximately 300mm layers and compacted thoroughly as the structure is restored. The final layer was topsoiled and seeded with grass and fertilised to promote revegetation.

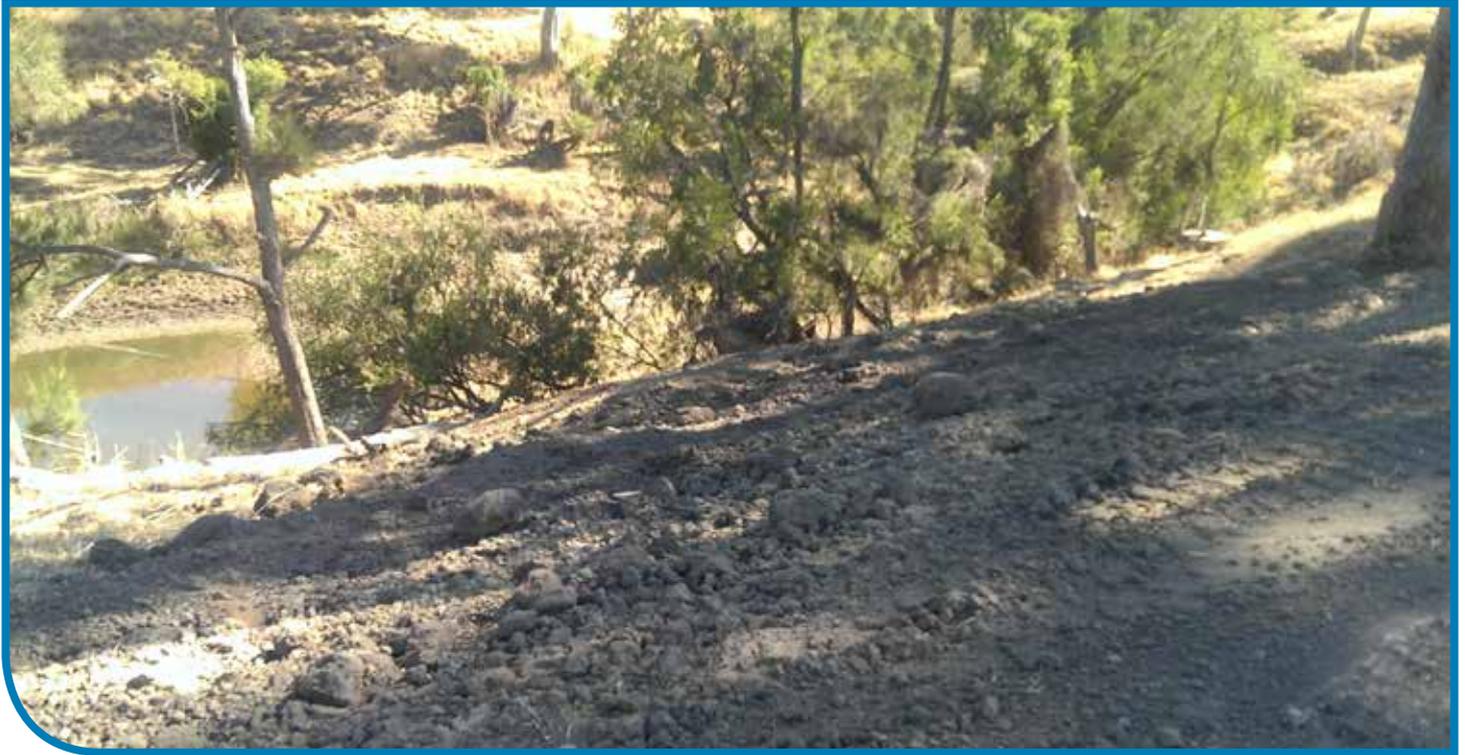
The repaired levee bank following earthworks and the addition of seeded topsoil

The restored natural creek levee was designed to prevent stream water exiting the primary channel of Three Moon Creek during moderate flood events.

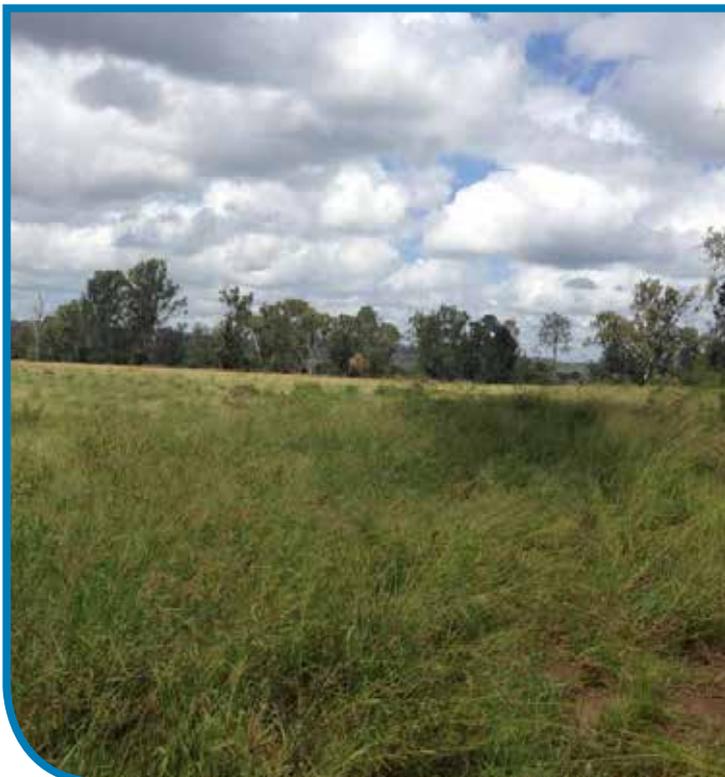
Significant flooding caused by Tropical Cyclone Marcia in February 2015 has proved the effectiveness of the project with the restored natural levee incurring no damage and the adjacent agricultural land remaining free of erosion and scouring.

The natural levee bank was not breached despite the significant flooding caused by Tropical Cyclone Marcia protecting the adjacent land from scouring and erosion
