Flood Recovery Case Study

Drainage Channel Assists Flood Mitigation

Campbell's Rd Drainage Channel Barambah Creek - Bye South Burnett

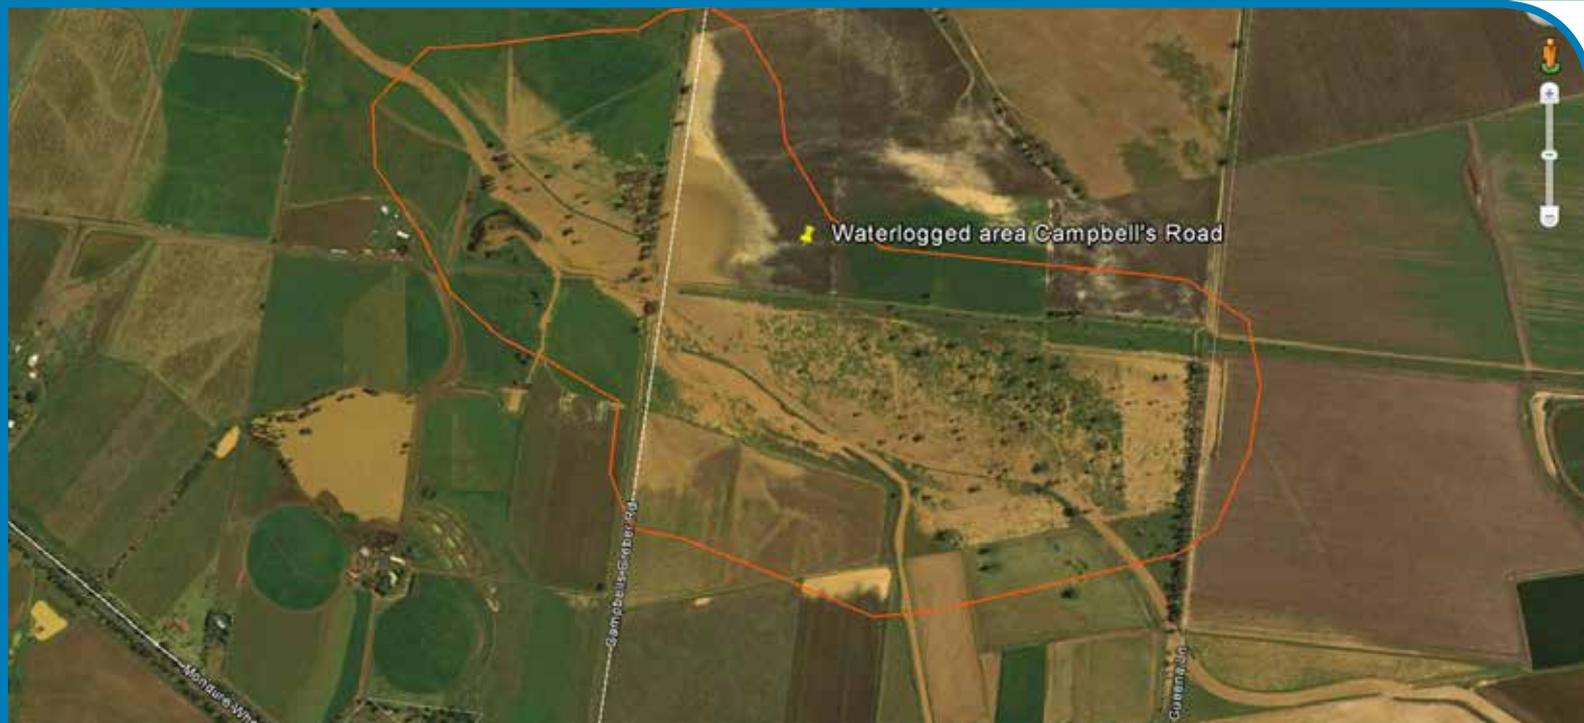
The waterlogged area of Campbell's Rd following the January 2013 flooding and prior to commencement of the drainage project

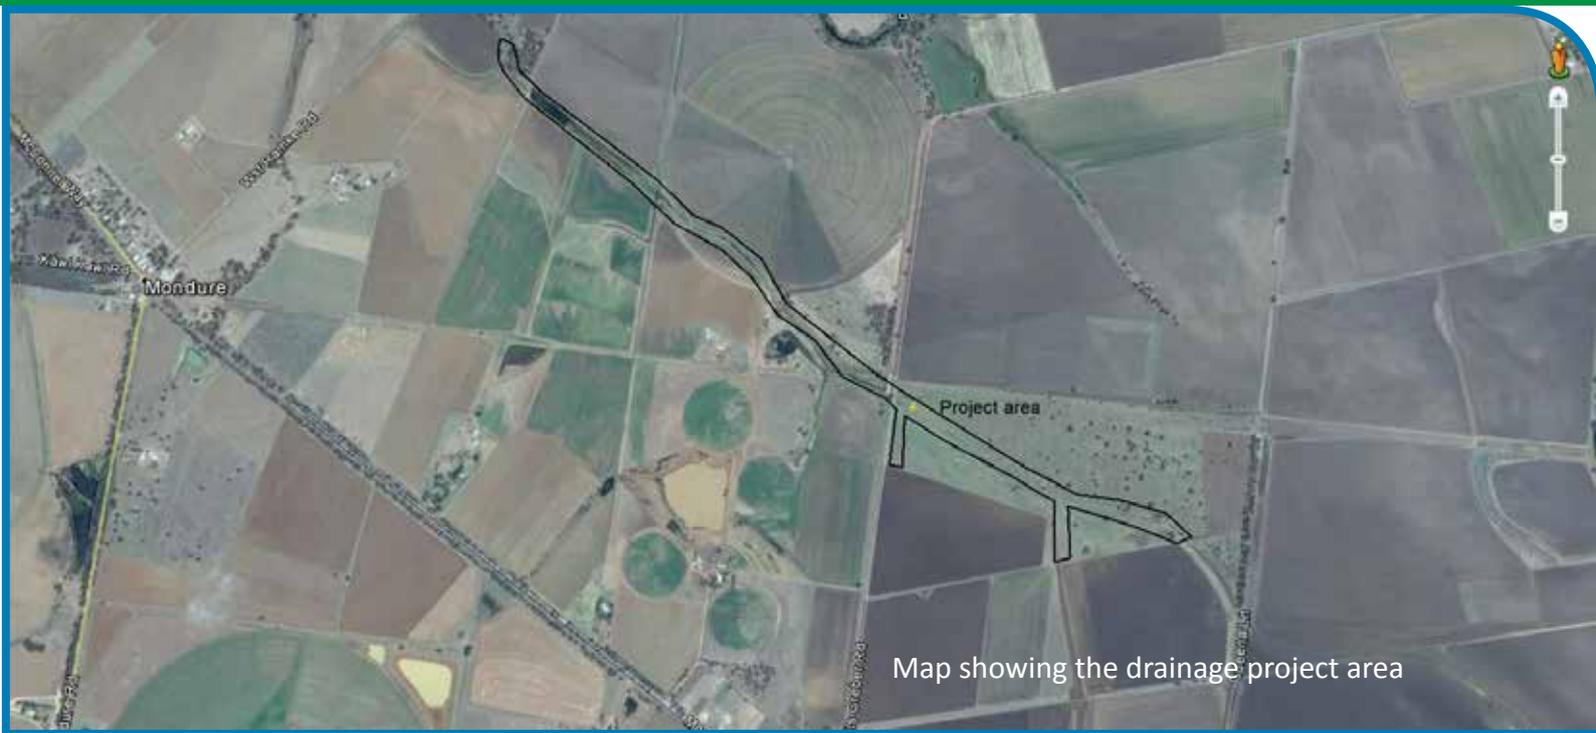
Map showing the drainage project area

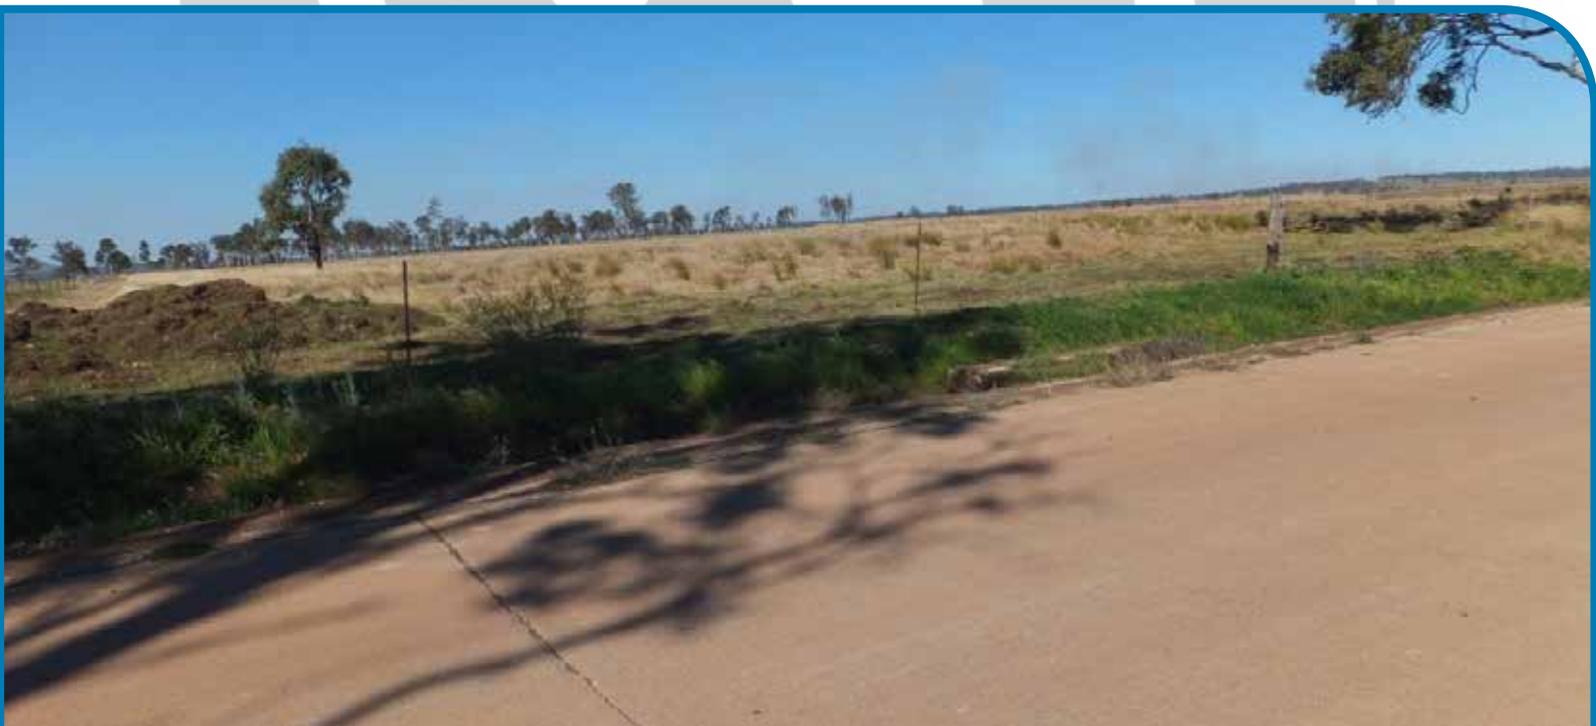
Upstream Prior to Construction

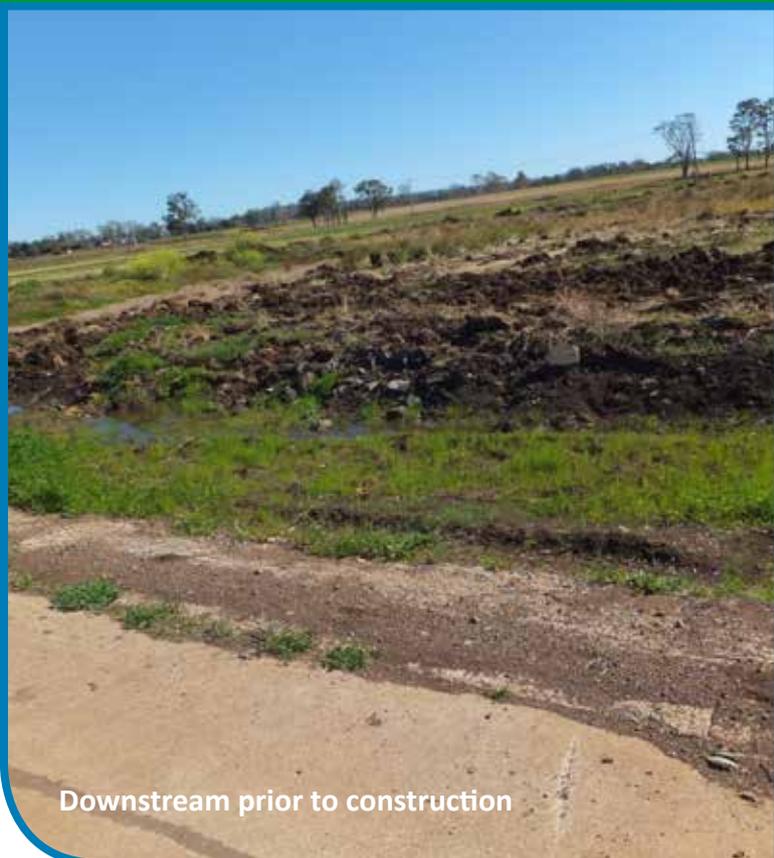
Downstream prior to construction

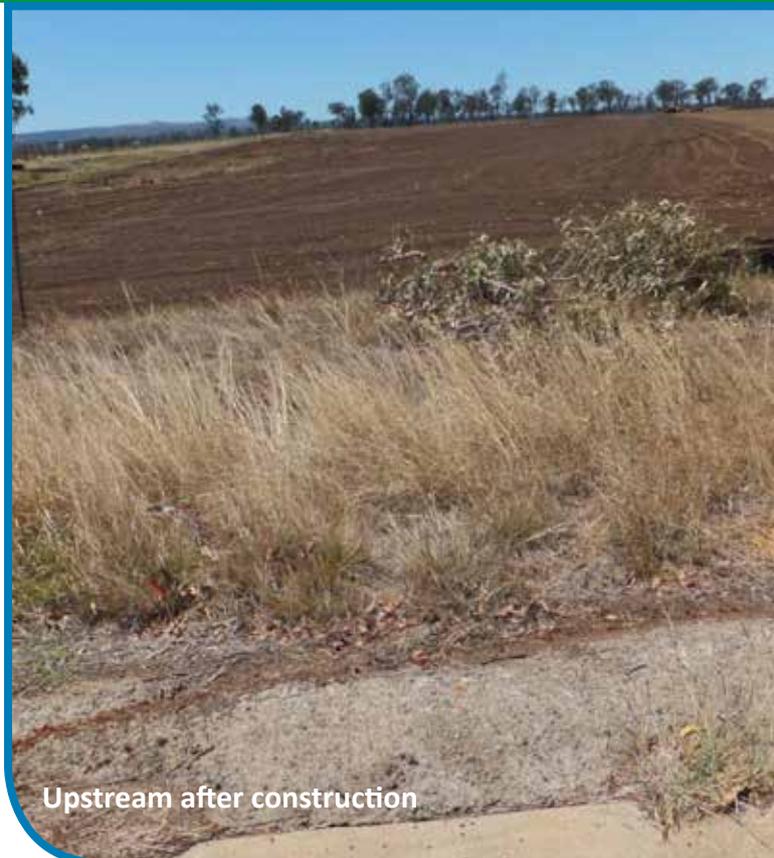
Upstream after construction

The project work proceeded with a drain being constructed to an average width of 20 metres, an average depth of 0.4 metres and a length of approximately 2 Kilometres through three properties and the road reserve. Construction was completed and the area was revegetated with crops and pasture grasses. The project was blessed with an extended period of dry conditions which allowed earth works to continue long into the normal wet season period. With this favourable weather the project was completed before any irrigation or run of water presented in the drainage line. Landholders took advantage of the construction to do complementary works on their properties which has resulted in a very efficient and productive system which will reduce future waterlogging and provide a model for floodplain drainage construction.
